Manhole Inspection Summary

Manhole # S41QQ_014MH

Insp Date: **4/3/07 11:55 AM**

Location Address: **1203 25TH ST**

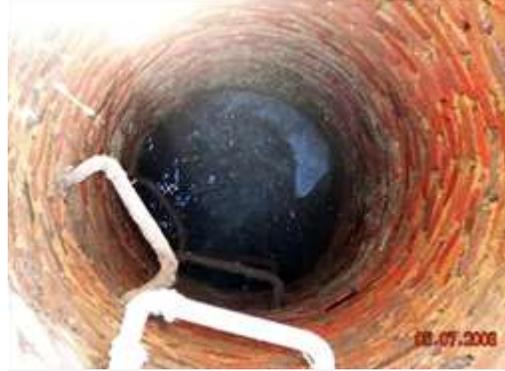
Top View

Corroded steps. Evidence of surcharge - Bench debris.

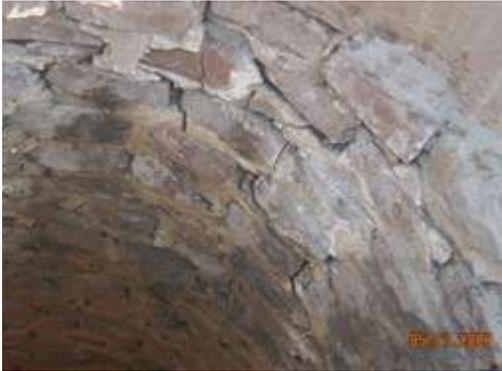
Defect

Frame leaks. Adjustment and Corbel deterioration, cracks and infiltration.

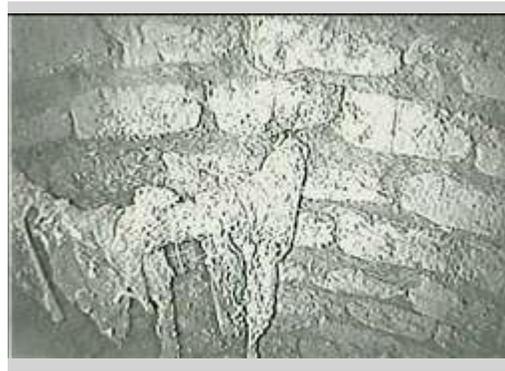
Defect

Evidence of surcharge.

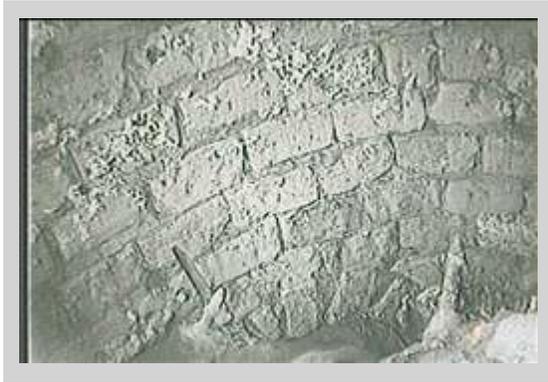
8 in. Circular Gravity Sewer Pipe Out @ 12 O'Clock

Barrel deterioration and infiltration.

Deposits: None **Mud** Sludge **Debris** **Grease**

Silt Depth: **2** (in.) Deposits Extent: **Medium**

Infiltration: **Evidence** Pipe Seal Cond: **Unknown**

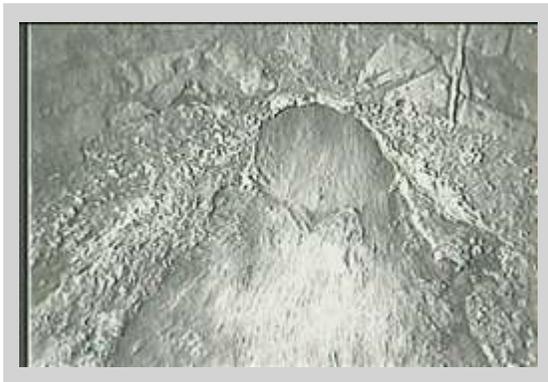
8 in. Circular Gravity Sewer Pipe In @ 8 O'Clock

Barrel deterioration and infiltration.
